PCB layout

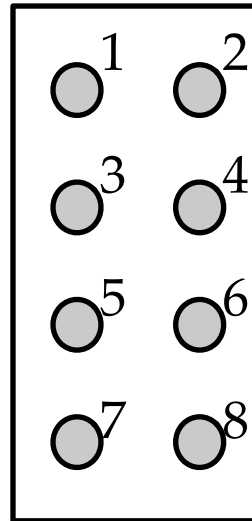
C3 removed

C6 removed

50 ohm

Replacement part

PSCQ-2-120

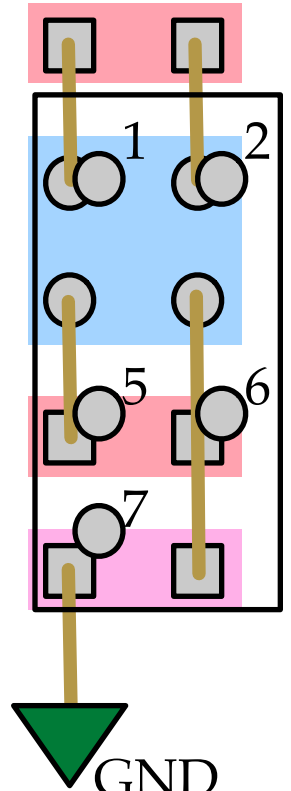
Pin connections

Pins 3, 4, 8 (all GND)
not connected

R4 = 50 ohms still in place
